EVALUATION OF EDMONDS MARSH AND SHELLABARGER MARSH BUFFER ZONES

Prepared for

Edmonds City Council

June 1, 2018

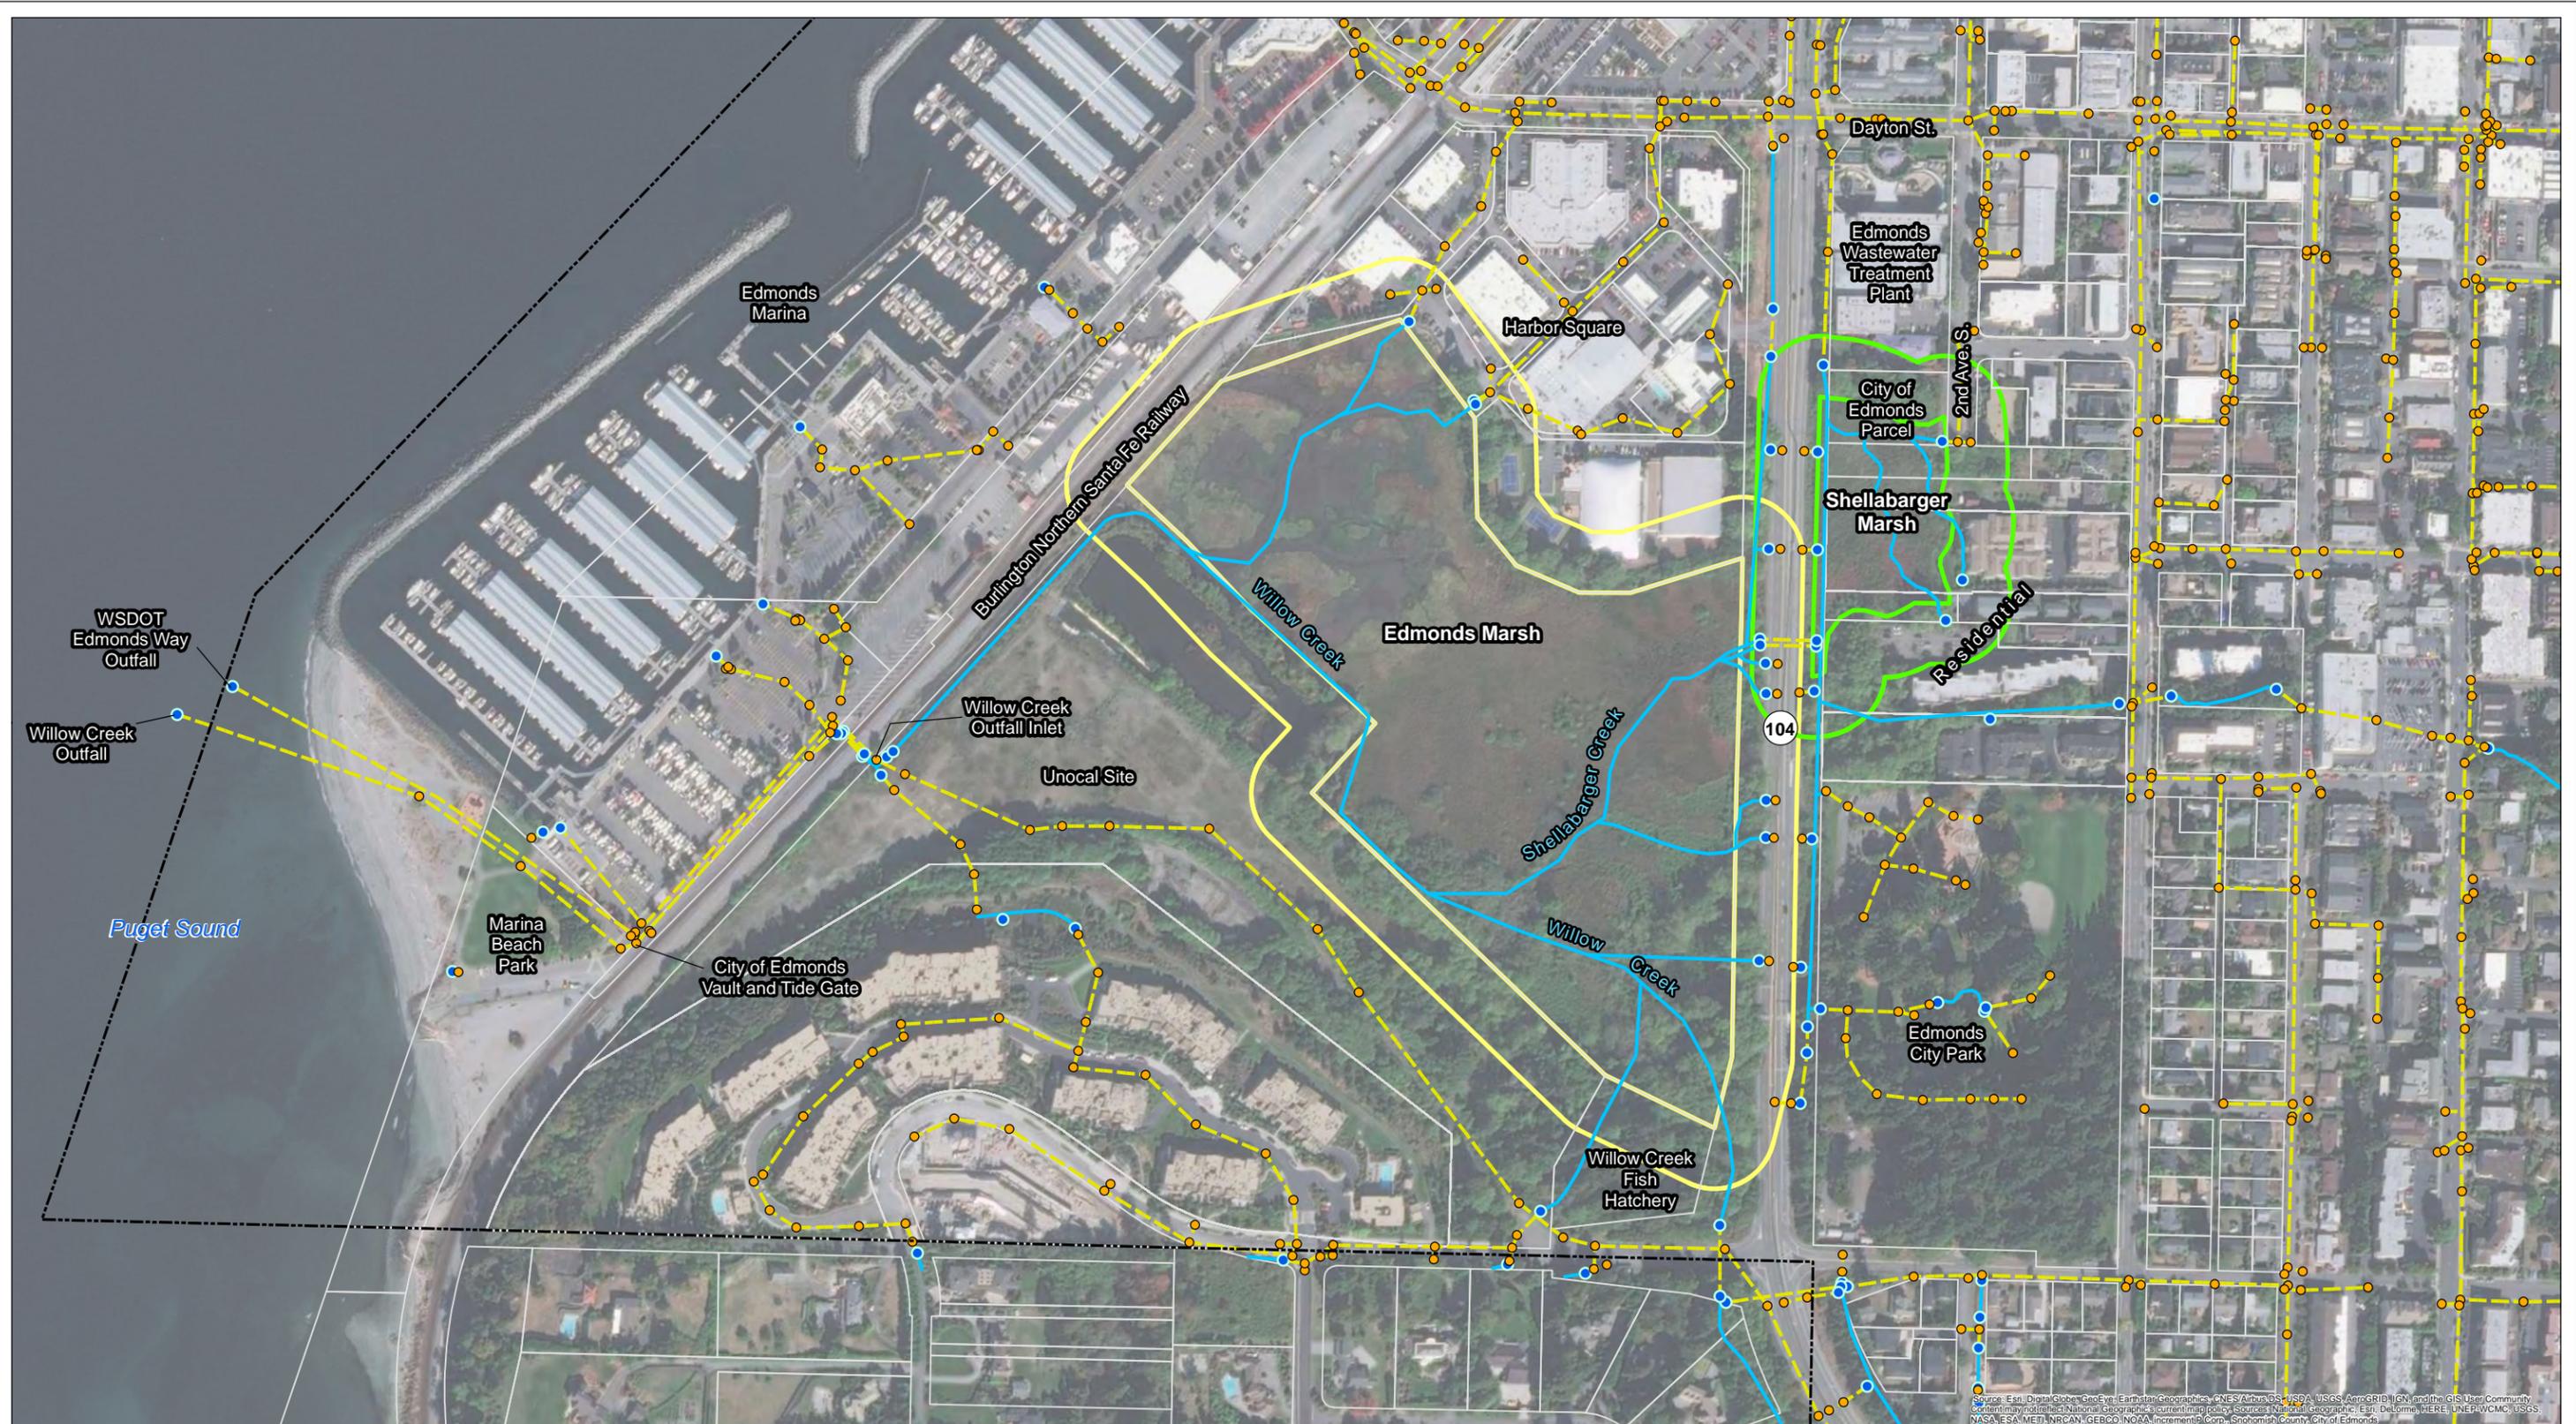
Figure 2. Stormwater and surface water features and buffer zone boundaries

Stormwater enters Edmonds Marsh from the Harbor Square property and Dayton Street via two stormwater outfalls (Figure 2). After exiting the outfall, the stormwater flows through small drainage ditches (approximately 20 to 30 ft long) located near the lowest portion of the northern buffer zone (nearest the Marsh perimeter). The water then flows into patches of cattail (*Typha latifolia*) and other emergent vegetation at the Marsh perimeter (Photo 3 in Appendix A).

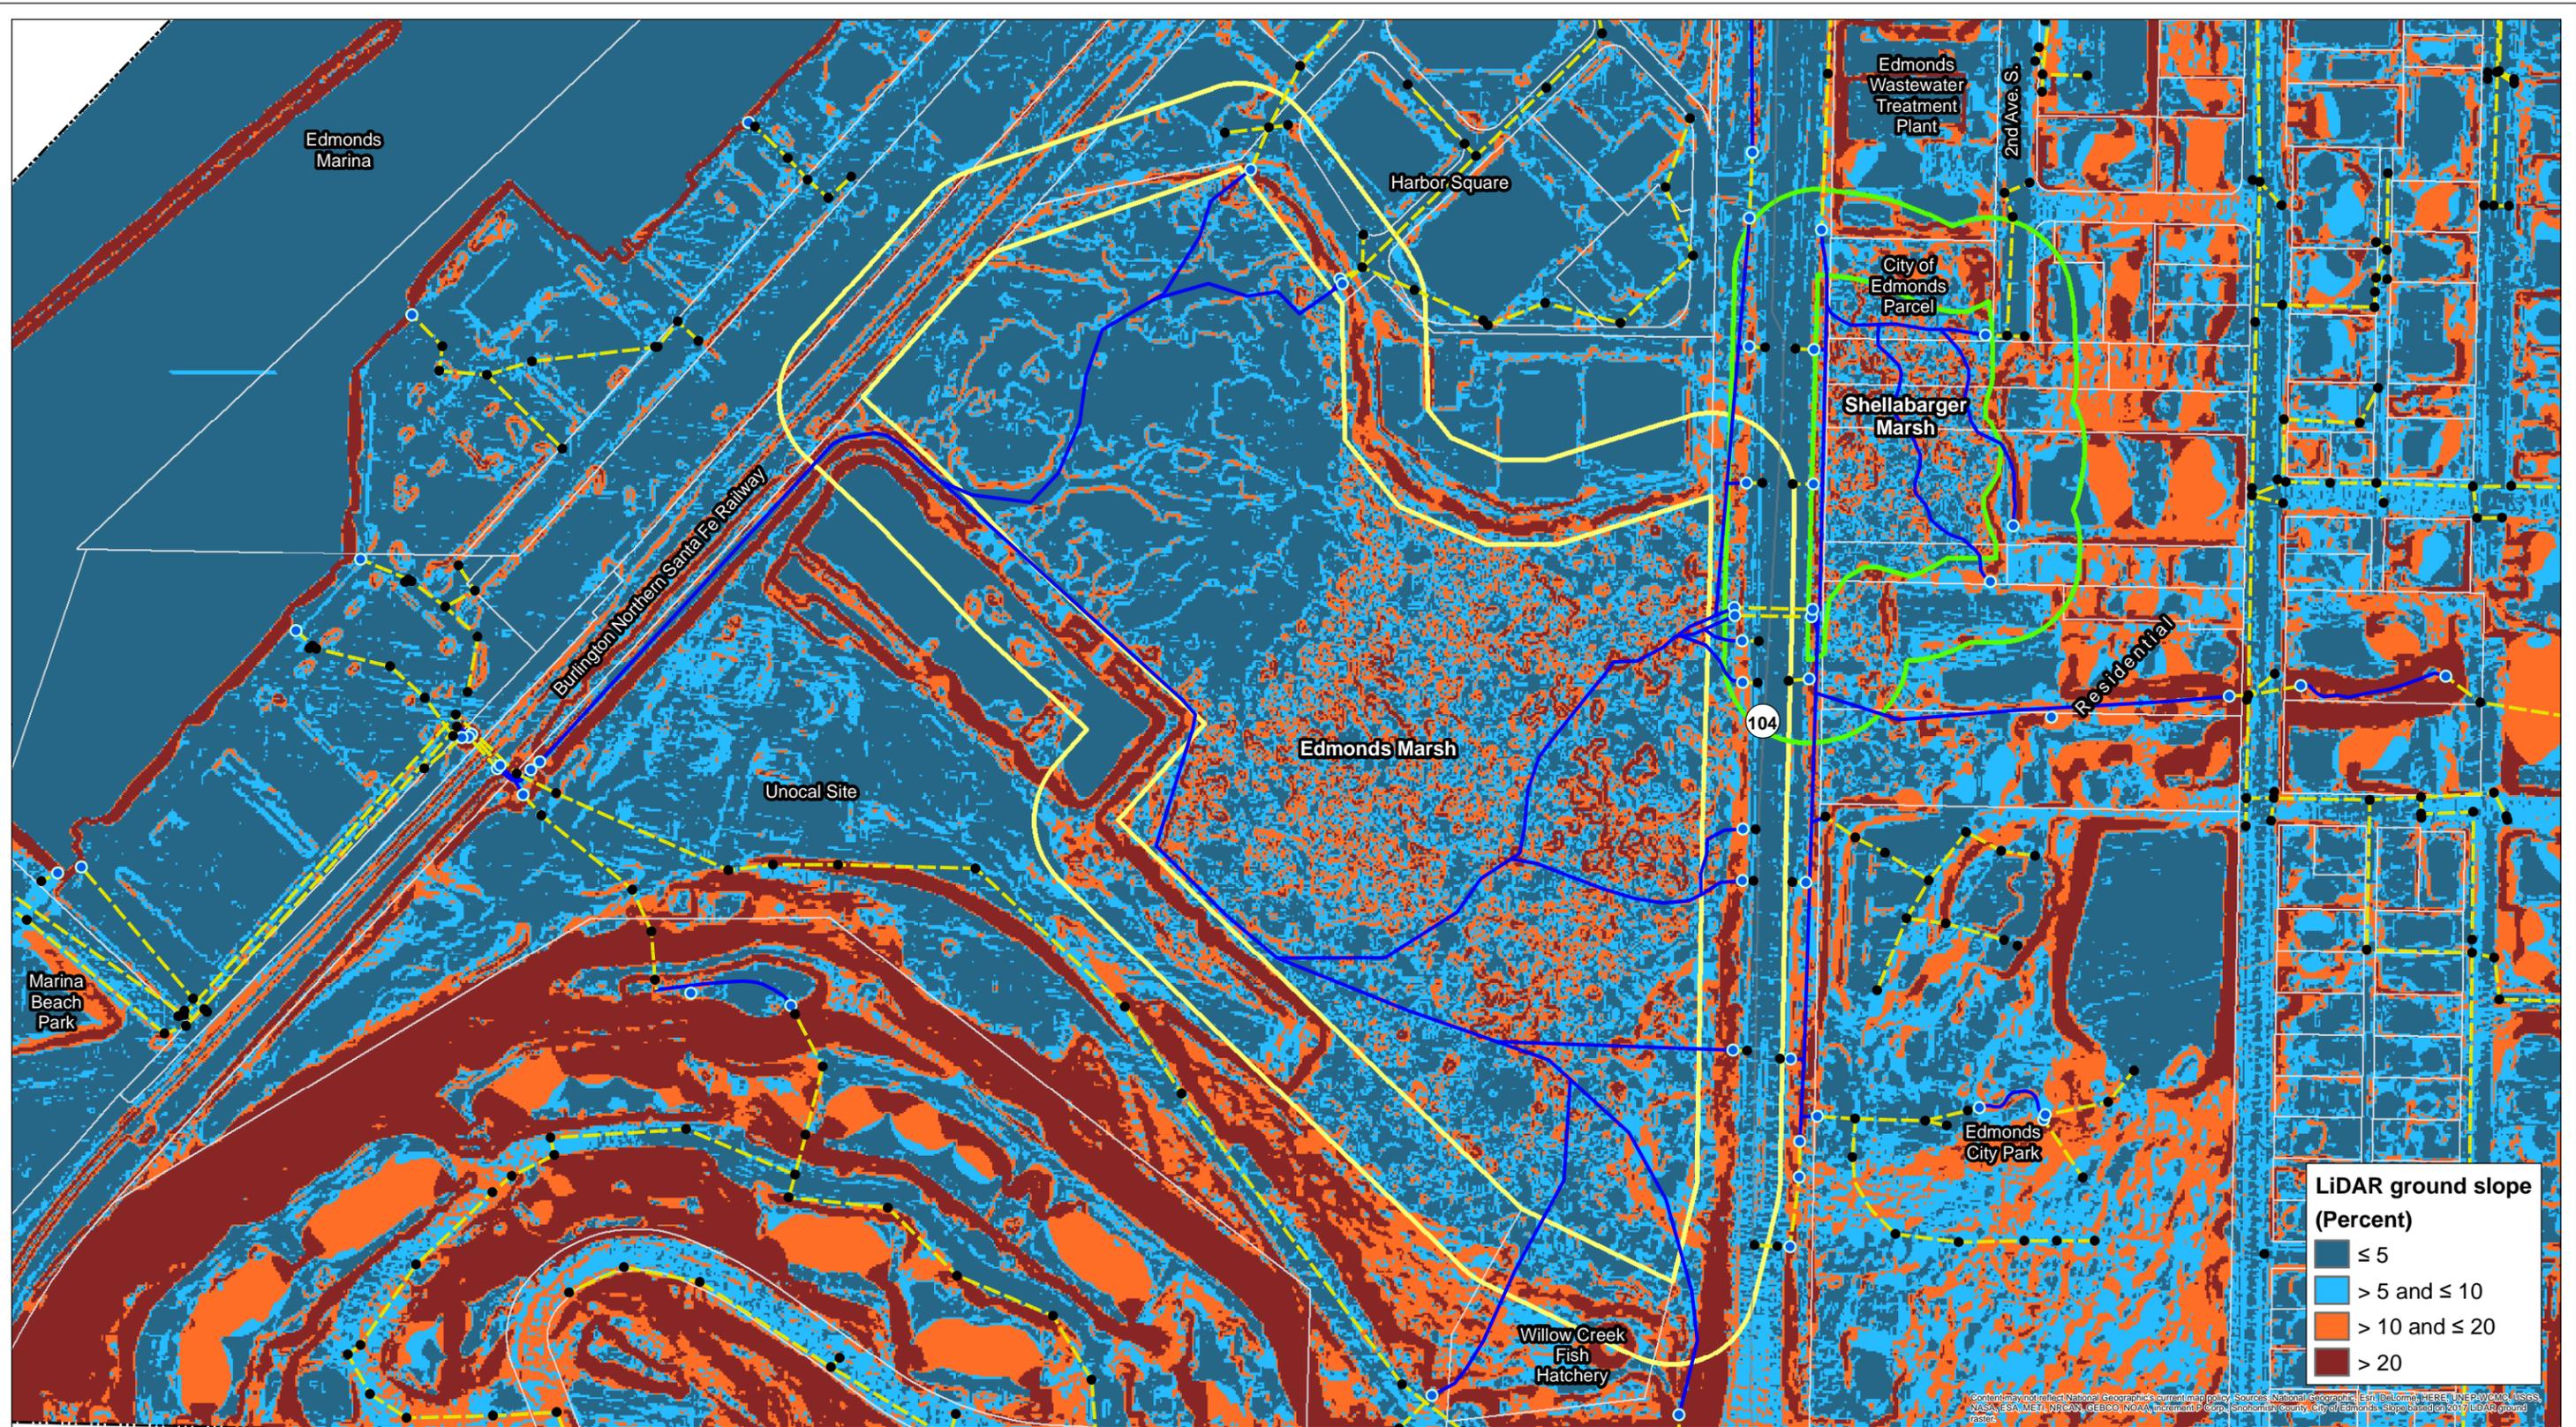
Figure 3: Edmonds Marsh and Shellabarger Marsh buffer zone gradients

The area referred to here as the northern buffer zone of Edmonds Marsh begins at the edge of the Burlington Northern Santa Fe (BNSF) railroad right-of-way and extends eastward to SR 104, following the northern, curved boundary of the Marsh, as shown on Figure 2. Owned by the Port of Edmonds, this area contains buildings, paved areas, and recreational facilities (e.g., tennis courts and a paved trail) associated with the Harbor Square property. The gradient of the vegetated portion of the northern buffer zone is relatively steep (greater than 20% in some areas) as the topography transitions quickly from the developed upland area to the Marsh (Figure 3).

A drainage ditch within a grassy area just to the north of the eastern buffer zone running adjacent and parallel to SR 104 (Photo 4 of Appendix A and Figure 2) carries stormwater from the highway, Dayton Street, and other areas to the north. Dense vegetation (primarily cattails) was observed within the ditch. Ultimately, this ditch flows into the eastern buffer zone and then joins Shellabarger Creek near the location where the creek flows into Edmonds Marsh. The gradient of the eastern buffer zone in the vicinity of the drainage ditch is generally 10% or less (Figure 3).

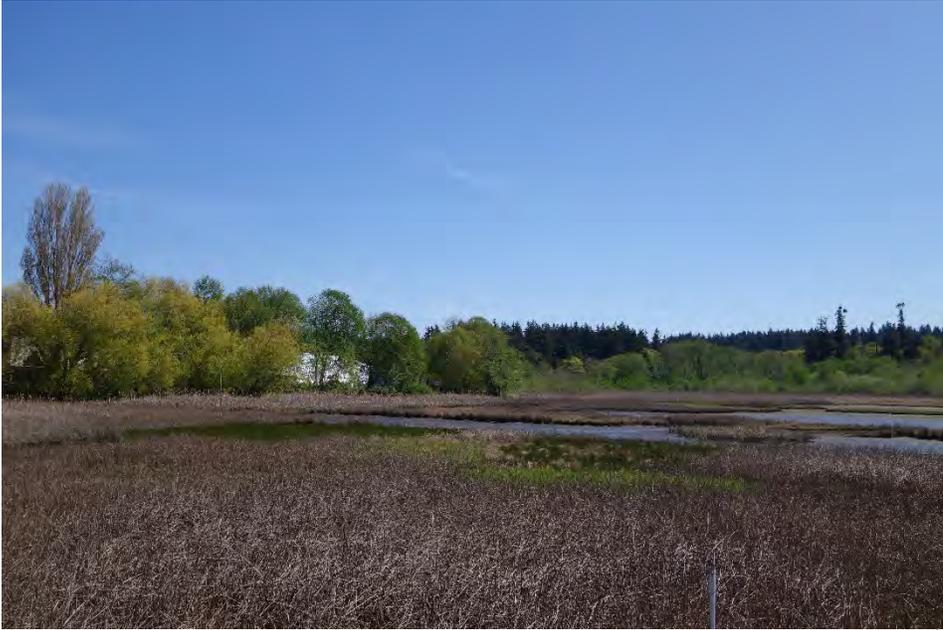
Vegetation in the northern buffer zone consists of both native and non-native species, with a relatively dense tree canopy ringing the eastern two-thirds of this buffer zone (Photo 1 in Appendix A). The understory includes a variety of native shrubs, many of which appear to have been planted relatively recently (Photo 2 in Appendix A).

| <p>Description: View to the southeast from the boardwalk located near the Harbor Square property. The photo shows the strip of primarily native trees and shrubs along the eastern portion of the northern buffer zone in the background, with emergent and mudflat habitat within the marsh interior in the foreground.</p> | | |

Although only a portion of the Edmonds Marsh northern buffer zone is vegetated, the existing vegetation appears to be of high quality in terms of native species diversity, and provides a visual screen between human activity and the Marsh interior. Habitat restoration efforts already conducted in this zone have certainly contributed to its diverse mix of native plants. As the young plants recently installed in the understory continue to grow, they will provide a denser buffer between the pedestrian path and the Marsh; they will also provide a source of conifer trees to grow and replace the overstory alder and willow as they naturally decline over time. If the vegetated portion of the northern buffer zone were ever to be widened, it would likely further reduce disturbance to wildlife using the Marsh.

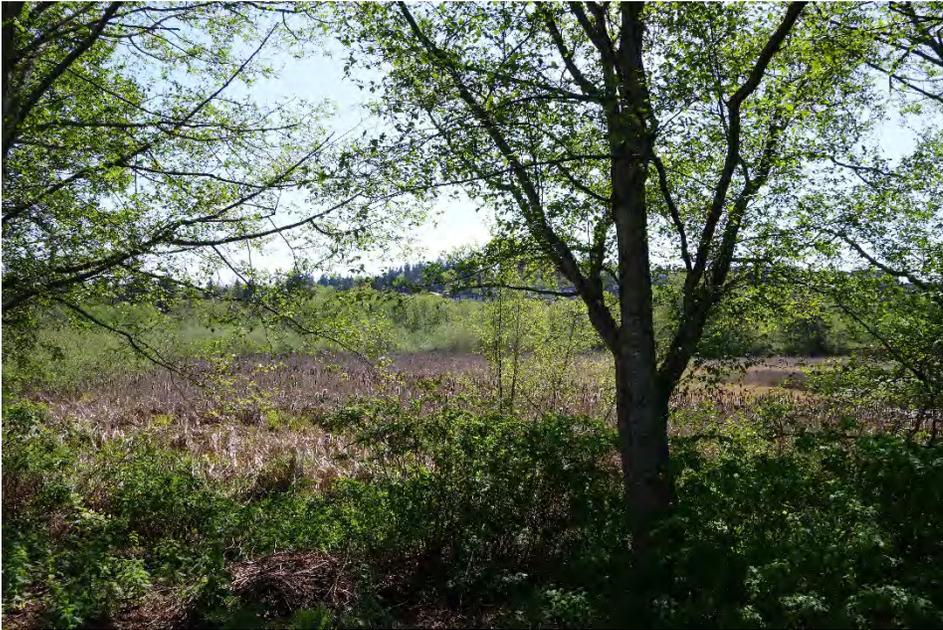
| <p>Description: A close-up view of the vegetated strip located in the eastern portion of the northern buffer zone.</p> | | |

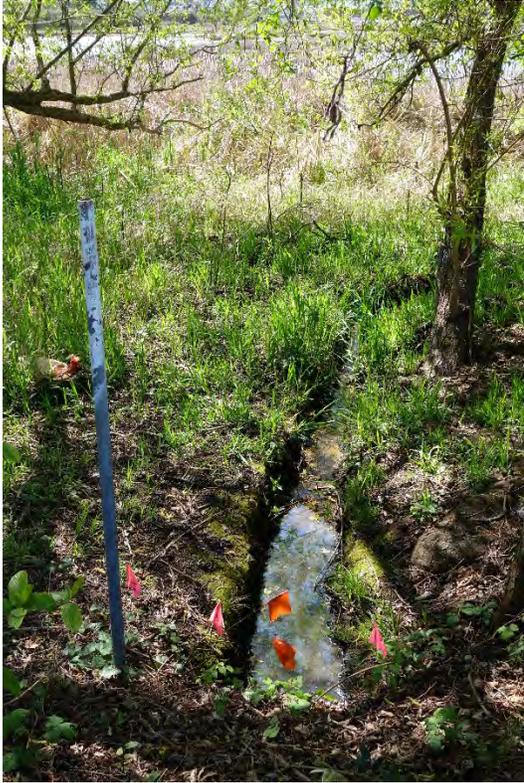
| <p>Description: View of one of the storm drain outfalls that discharges to Edmonds Marsh within the northern buffer zone. After exiting the outfall, stormwater flows through an unlined ditch into the marsh.</p> | | |

In general, the most effective water quality benefits are realized when buffers are wide, gently sloping, and densely vegetated, primarily because these characteristics lengthen the time it takes surface water to flow from the outer edge of the buffer zone to the wetland. Widening the flow paths of the two drainage ditches within the northern buffer zone, and planting additional native emergent plants (e.g., slough sedge [*Carex obnupta*], other native wetland plants that tolerate partial shade) between the storm drain outfalls and the Marsh may also boost the ability of this area to provide water quality improvements. An additional recommendation for the northern buffer zone is to further evaluate areas where stormwater may be flowing through the buffer zone as sheet flow.

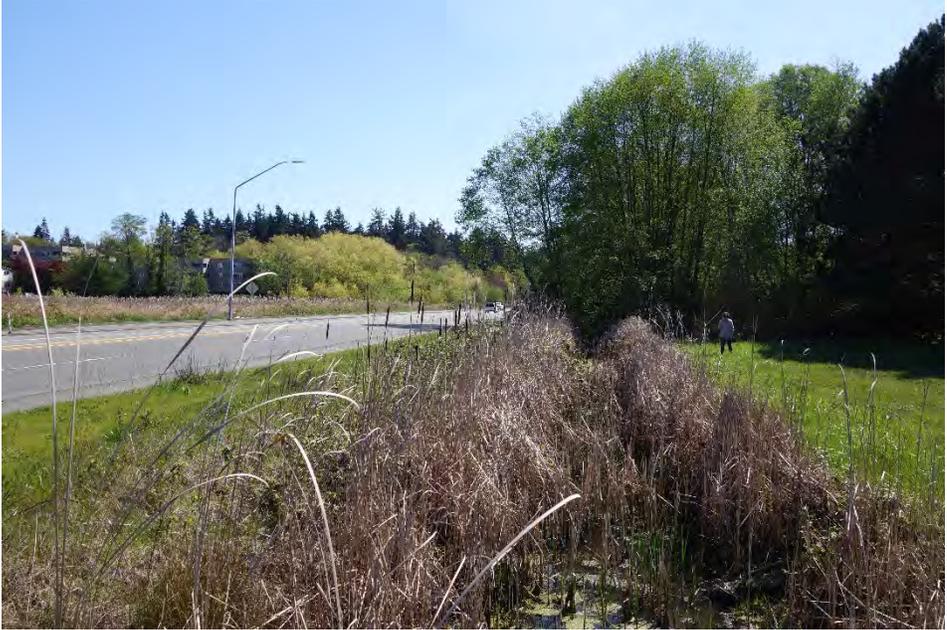
| <p>Description: View to the south from the drainage ditch located adjacent to Highway 104, just north of the eastern buffer zone.</p> | | |

The drainage ditch north of and extending into the eastern buffer zone presents a possible opportunity for enhancing stormwater quality functions, if stormwater continues to be conveyed through the ditch after the Dayton Street Pump Station has been constructed. The drainage ditch is adjacent and parallel to SR 104, and carries stormwater from the highway, Dayton Street, and other areas to the north (Figure 2). As the gradient in at least a portion of this area is relatively low (generally $\leq 10\%$ as shown on Figure 3), the ditch is filled with cattails (which are known to help filter sediments and other stormwater pollutants), and as stormwater flows via the ditch for

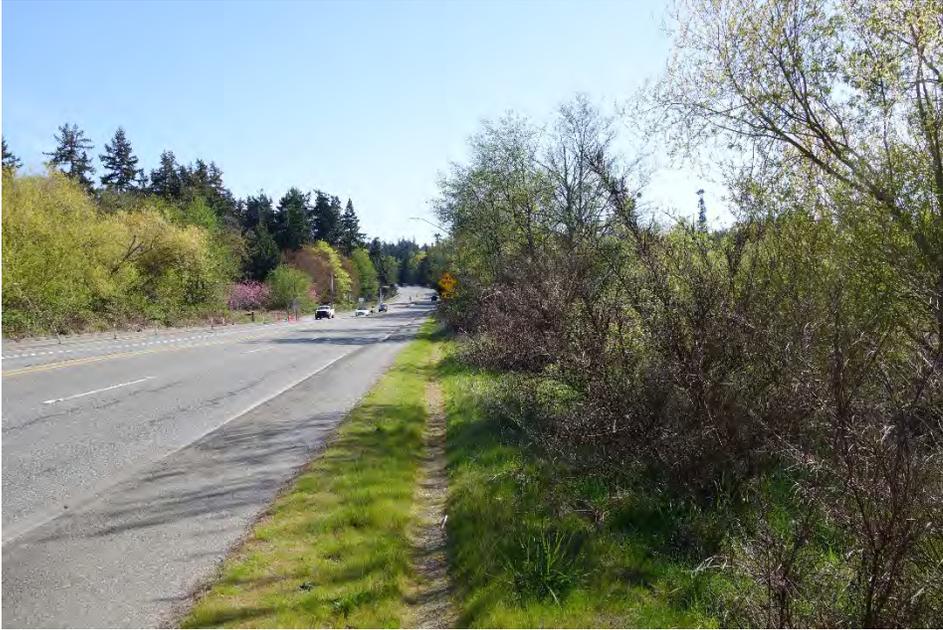
The eastern buffer zone of Edmonds Marsh is largely occupied by SR 104 (Figure 2 and Photo 5 in Appendix A), with a relatively dense strip of established shrubs and trees between the highway and the Marsh. Quite narrow in the northern portion of the eastern buffer zone, this strip consists of a canopy of red alder and a single Douglas fir (*Pseudotsuga menziesii*) with an understory of Himalayan blackberry (*Rubus armeniacus*), Scotch broom (*Cytisus scoparius*), and Pacific willow. Near the location where Shellabarger Creek passes via the double culverts from Shellabarger Marsh to Edmonds Marsh (Figure 2), cattails extend from the Marsh all the way to the sidewalk along the highway. The invasive species bittersweet nightshade (*Solanum dulcamara*),

| <p>Description: View to the south along SR 104 showing the relatively narrow strip of vegetation within the northern portion of the Edmonds Marsh eastern buffer zone.</p> | | |

In the middle portion of the eastern buffer zone, where buffer vegetation grows in a very narrow strip along the highway, the current recommendation is to leave the existing thicket of Himalayan blackberry. While this plant is invasive and generally not desirable in natural areas, it provides an effective barrier to people and domesticated animals, as well as food, nesting sites, and shelter for birds and small mammals (USFS 2018). Himalayan blackberry is also hearty, even in a harsh environment like that found along the SR 104 corridor.³ Invasive species control efforts in this area could be focused on removing Scotch broom before it spreads to other areas.

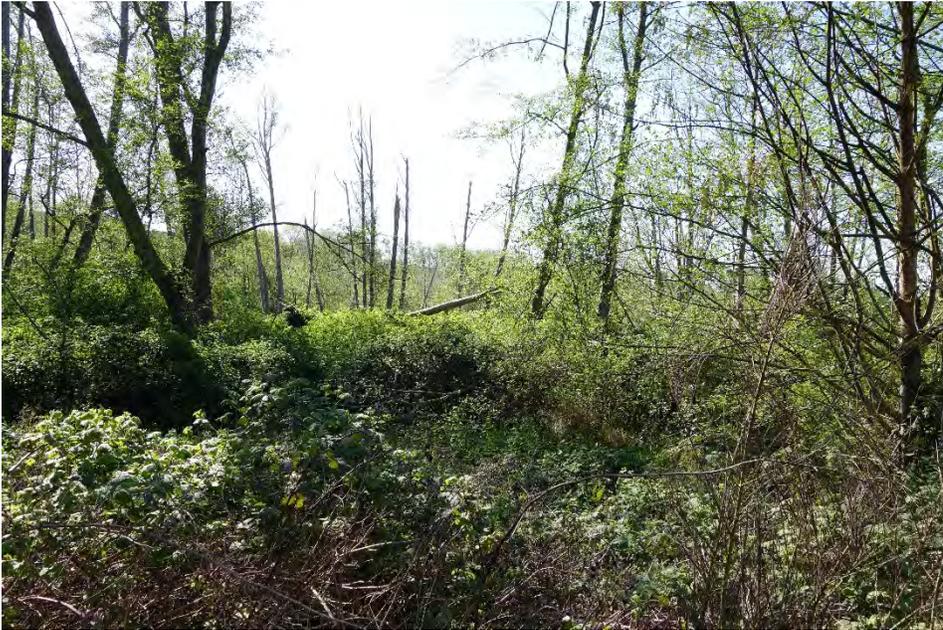
| <p>Description: View to the west (toward the interior of Edmonds Marsh) from the southern portion of the eastern buffer zone. The photo shows the declining condition of alder trees present in this area, as well as the dense growth of Himalayan blackberry in the understory.</p> | | |

The southern portion of the eastern buffer zone (the area between the hatchery property and the highway) would benefit from removal of Himalayan blackberry and other invasive species, and from the installation of native shrubs and groundcover plants in the understory. Native tree species tolerant of shade and moisture (such as Oregon ash [*Fraxinus latifolia*] or western hemlock) could also be installed to help replace the declining alder in this area. If habitat restoration efforts are to be conducted within the hatchery property, they could perhaps be extended into the eastern buffer zone.

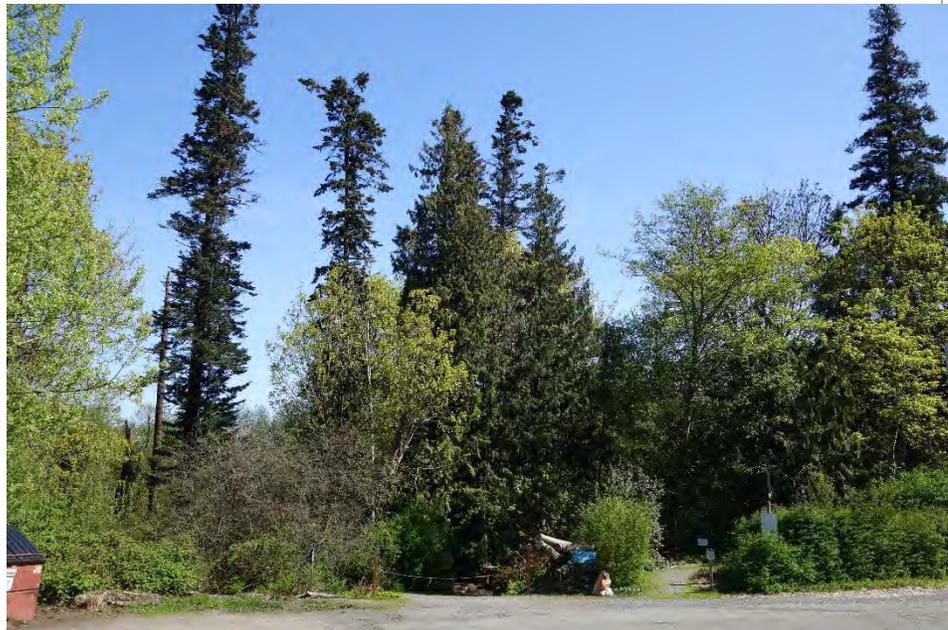
The canopy within the buffer zone contains a mix of native tree species, including red alder, bigleaf maple, Douglas fir, western red cedar, and western hemlock (see Photo 7 of Appendix A). The understory contains a variety of native shrub and ground cover species, including salmonberry, ososberry, red-osier dogwood, red-flowering currant, vine maple, western red cedar seedlings and saplings, red elderberry, stink currant (*Ribes bracteosum*), lady fern, fringecup (*Tellima grandiflora*), youth on age (*Tolmiea menziesii*), lily-of-the-valley (*Convallaria majalis*), western bleeding heart (*Dicentra*

Description: View to the northeast from Pine Street showing the entrance to the Willow Creek Fish Hatchery. The background of the photo provides a good representation of the forest conditions within the southern buffer zone.

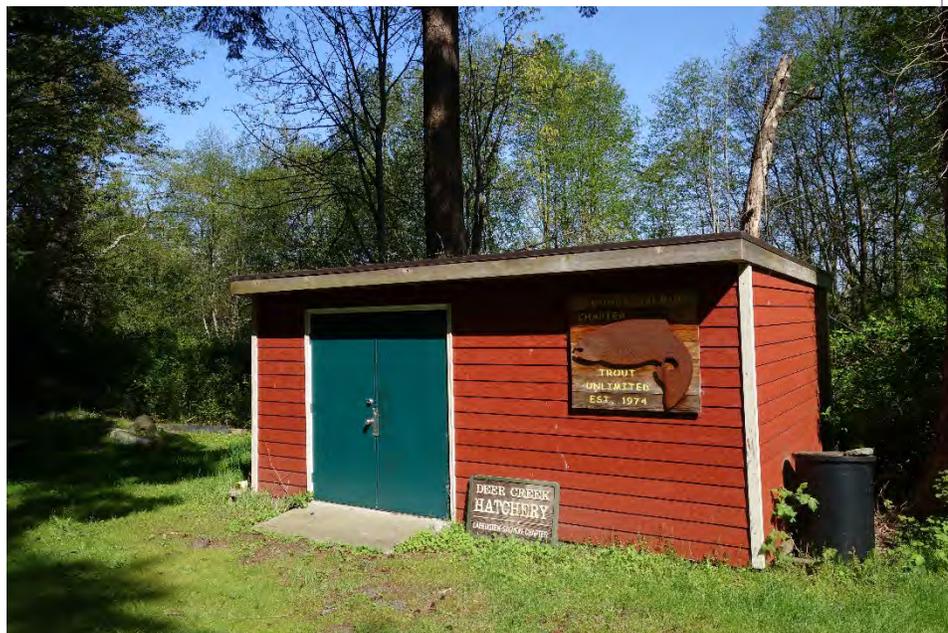
Photo No.: 8

The southern buffer zone, which includes the portion of the buffer located on the Willow Creek Fish Hatchery property, is owned by the City. Two small structures (Photo 8 of Appendix A shows one of the buildings) and a fish rearing pond are located on the property, which is operated by Sound Salmon Solutions. The gradient of the southern buffer zone ranges from $\leq 5\%$ to greater than 20%; the slope becomes less steep moving south to north (toward the Marsh) within this zone (Figure 3).

Description: View to the north from one of the buildings associated with the hatchery. With the exception of the hatchery buildings, pools, and access road, most of the southern buffer zone is heavily vegetated, as visible in the background of the photo.

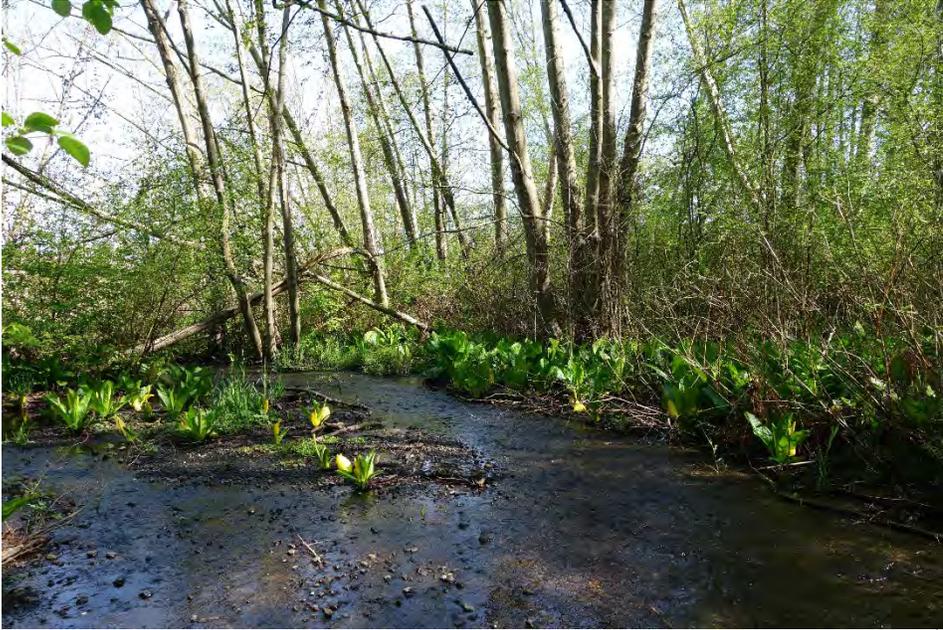
formosa), and a good number of skunk cabbages (*Lysichitum americanum*) beneath the tree canopy along Willow Creek (Photo 9 of Appendix A).

| <p>Description: View to the north from the southern buffer zone, within the Willow Creek Fish Hatchery property. The photo shows Willow Creek flowing toward Edmonds Marsh, and the surrounding forested wetland habitat.</p> | | |

Finally, while a relatively large quantity of LWD was observed within the southern buffer zone, little to no LWD was observed within the Willow Creek channels (Photo 9 of Appendix A). The placement of LWD within the creek channels, or natural recruitment of LWD in the event that streamside trees should fall, would provide beneficial habitat complexity within the stream.

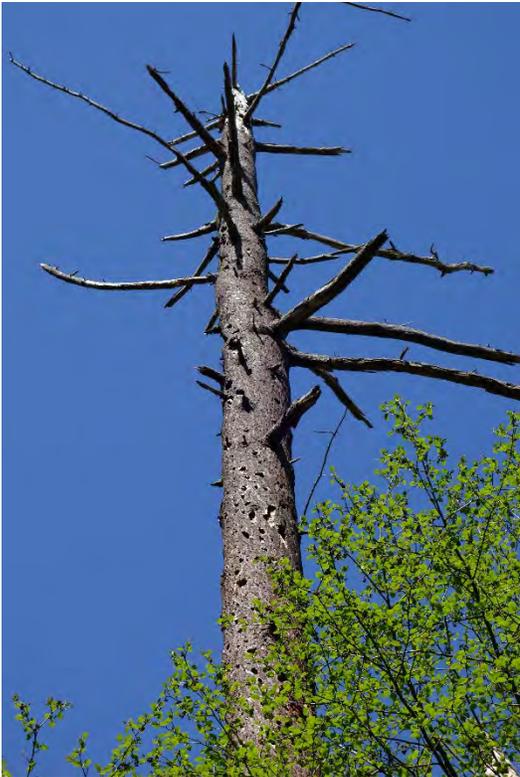
In addition to a diverse mix of native plants, the southern buffer zone also contains a relatively large amount of large woody debris (LWD), both standing and on the ground. This feature no doubt contributed to observed woodpecker and sapsucker activity. During the site reconnaissance, a downy woodpecker (*Pecoides pubescens*) was heard, and a pileated woodpecker (*Dryocopus pileatus*) was seen. In addition, an abundance of woodpecker holes were observed in standing snags (Photo 10 of Appendix A), and sapsucker holes were observed in downed wood. Other bird species observed in the southern buffer zone include MacGillivray's Warbler (*Geothlypis tolmiei*), Pine Siskin (*Spinus pinus*), Anna's Hummingbird (*Calypte anna*), Spotted Towhee (*Pipilo maculatus*), kinglets (Regulidae family), American Robin (*Turdus migratorius*), Bewick's Wren (*Thryomanes bewickii*), chickadees (*Poecile* sp.), and song sparrow (*Melospiza melodia*). Near where the western branch of Willow Creek enters the emergent portion of Edmonds Marsh, a song sparrow was observed carrying nesting material, indicating that the southern buffer zone also provides nesting habitat as well as foraging habitat.

| <p>Description: One of the standing snags with abundant woodpecker holes located in the southern buffer zone.</p> | | |

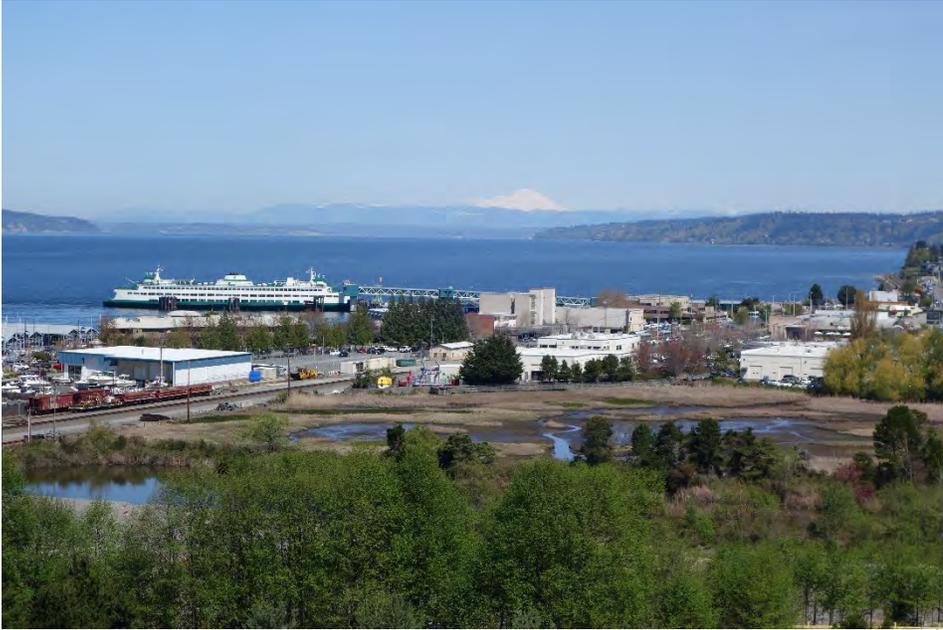
The southwest buffer zone of Edmonds Marsh includes the area from the western boundary of the Willow Creek Fish Hatchery northwest to the BNSF railway line (Figure 2). This buffer zone is located on the Unocal Property, which is owned by Chevron. The gradient of the eastern portion of this zone is relatively gentle (generally 10% or less); slope increases moving westward into the filled and developed portion of the Unocal site (Figure 3). Although access to this buffer zone was restricted, it was surveyed to the extent possible from the western portion of the Willow Creek Fish Hatchery property, the Point Edwards Community Trail, a lookout point within the

| Description: View of the southwest buffer zone, looking north from the lookout at Point Edwards. | | |

The primary recommendation for the southwest buffer zone currently is to conduct a more thorough evaluation of existing conditions. Additional surveys may be possible during a baseline study of the Marsh to be initiated in summer 2018, either by evaluating additional portions of the southwest buffer zone from the Marsh interior, or by obtaining Chevron’s permission for direct access to the property. Physical access appears to be feasible from the hatchery property, if such permission were to be granted. Much of this buffer zone appears to contain habitat similar to the southern buffer zone. If so, it would represent a relatively high-quality and contiguous forested buffer habitat.

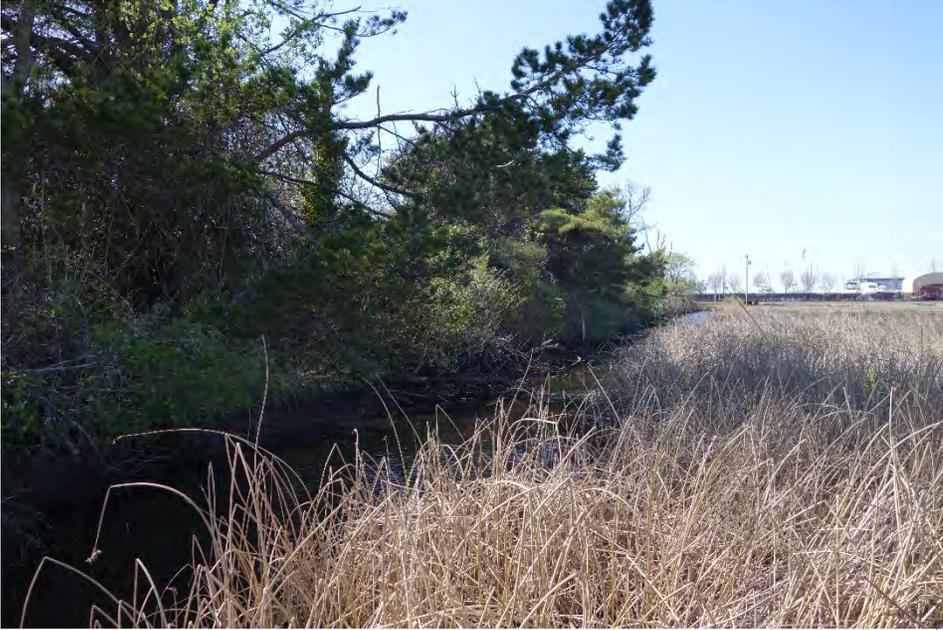
The eastern portion of this buffer zone contains forested upland and forested wetland habitat (Shannon & Wilson 2015) whose quality appears similar to that of the forested areas on the hatchery property. Tree species observed within the southwest buffer zone include bigleaf maple, red alder, Douglas fir, and western red cedar. A portion of this buffer zone (the northwest side, near the BNSF railway line) contains a stormwater detention pond associated with the Unocal site. Pine trees and salmonberry were also observed growing on the berm that separates the stormwater pond from the Marsh (see Photo 12 of Appendix A). Stormwater is reportedly pumped out of the pond into Willow Creek periodically (Shannon & Wilson 2015).

| Description: View to the northwest along the Willow Creek channel adjacent to the Unocal stormwater detention pond. Represents conditions within the southwest buffer zone. | | |

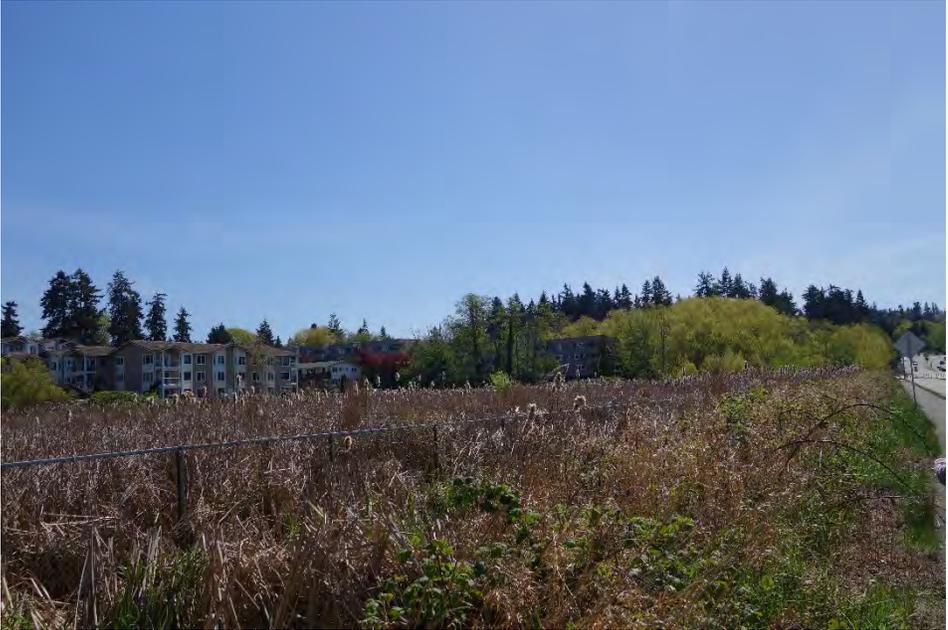
The western buffer zone of Shellabarger Marsh is largely occupied by SR 104, with a narrow strip of mostly non-native vegetation growing between the marsh and the road (Photo 13 of Appendix A). The vegetation here is a mix of cattails, reed

| Description: View to the southwest of Shellabarger Marsh western buffer zone, along Highway 104. | | |

Habitat enhancement possibilities are currently relatively limited in the eastern and western buffer zones of Shellabarger Marsh given the presence of large, multi-family residential developments and SR 104. However, water quality enhancements might be possible with improvements to vegetation and flow conditions in the area where channelized surface water now flows out of a culvert and through a portion of the eastern buffer zone (adjacent to a large condominium building) prior to entering Shellabarger Marsh (Figure 2). In addition, the City has recently been offered the opportunity to purchase the parcel of land immediately adjacent to the south of its undeveloped parcel within the northern buffer zone of Shellabarger Marsh (VanLoveren et al. 2018). The parcel for sale is undeveloped, covers approximately 0.67 ac, and includes portions of Shellabarger Marsh and its eastern buffer zone (Figure 1).

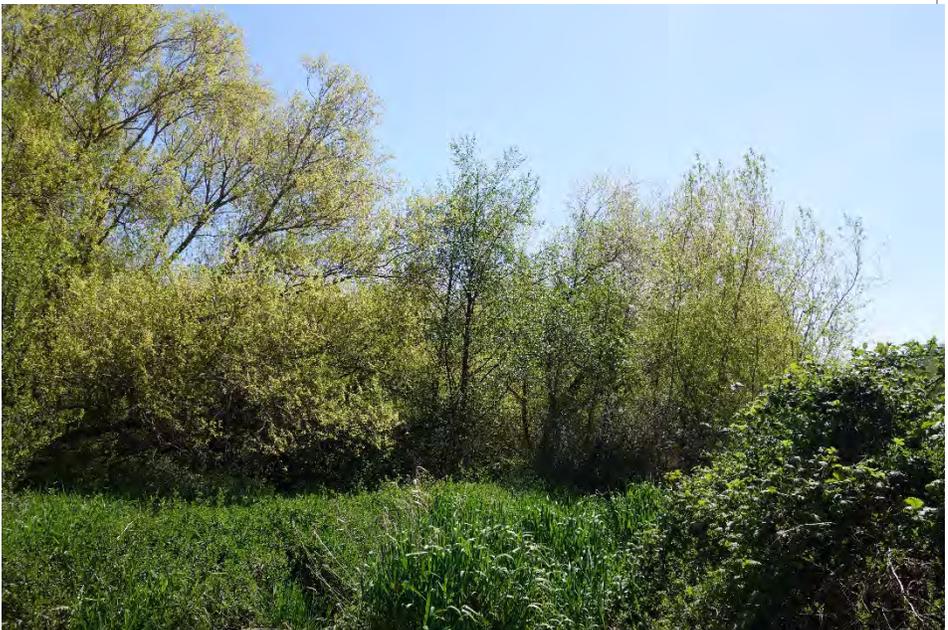
canarygrass, other grass species, and Himalayan blackberry. Pacific willow is also present toward the southern end of the western buffer zone, and to the east of the Edmonds Park Apartments and associated parking lot. In this same general vicinity, where the double culverts pass under SR 104 (Figure 2), a large dense patch of bittersweet nightshade is present, mixed with Himalayan blackberry and reed canarygrass (Photo 14 of Appendix A). Moving south from this area Himalayan blackberry is dominant beneath a canopy of Pacific willow.

| Description: View of the southern end of Shellabarger Marsh western buffer zone. Pacific willow are seen growing in the background, while reed canarygrass, bittersweet nightshade, and Himalayan blackberry are seen in the foreground. | | |
